CASE OF THE MONTH (March 2009)

Fractured Canine With
Pulp Exposure

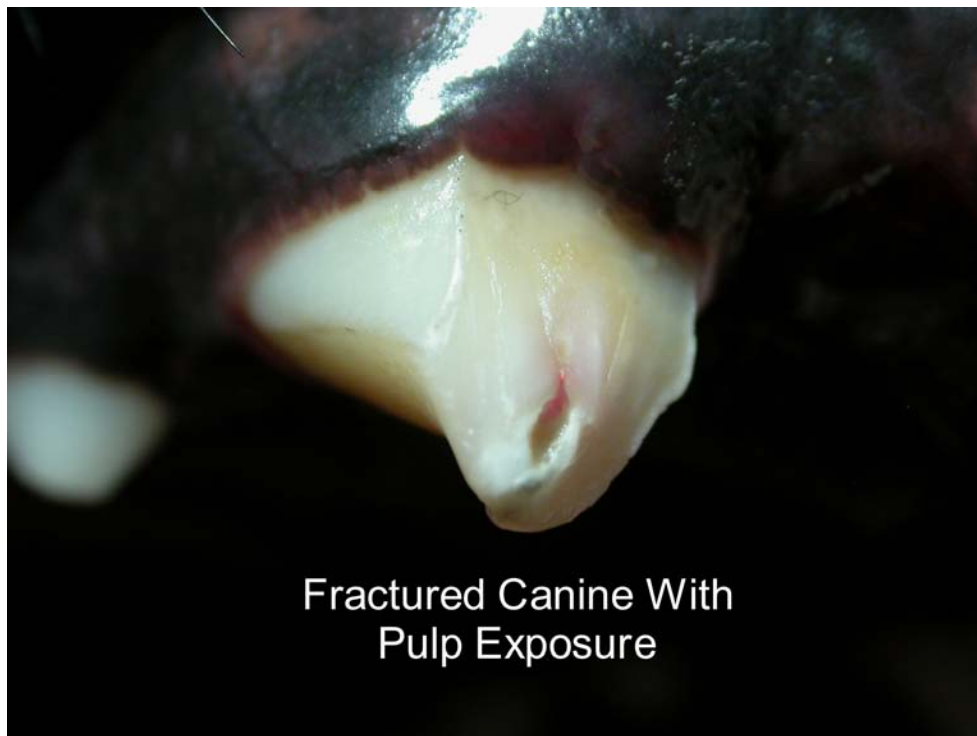
Signalment and History: A three year old intact male Belgian Malinois was referred from a military base with a fractured right maxillary canine tooth with pulp exposure. The fracture was oblique in nature and resulted in significant loss of crown structure on the mesial aspect of the tooth as well as loss of crown length. The fracture occurred as a result of “cage chewing” while the patient was confined to a kennel. This patient was a valuable member of a combat team and was trained as an attack dog as well as in the detection of explosives. Our goal was to return the patient to full active duty as soon as possible.
